# ***Building Report with Weathertightness Risk Assessment***

***14A Riverlea Road  
Hamilton***

***15 June 2026***

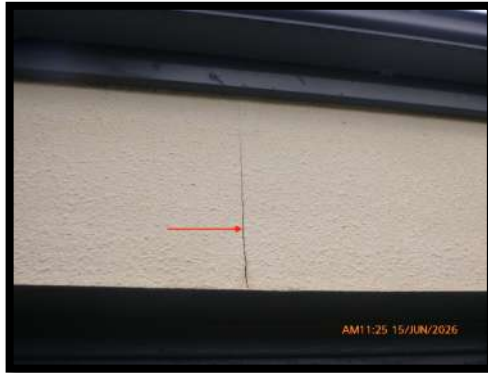
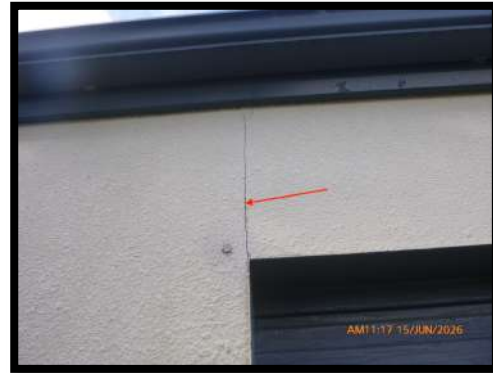
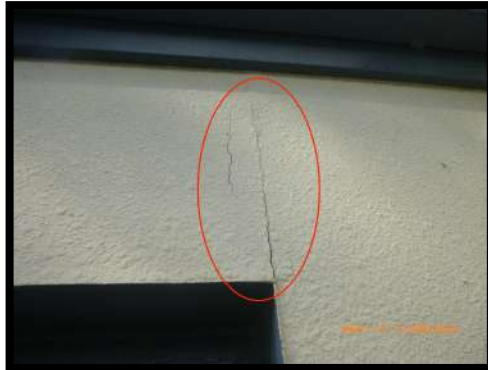
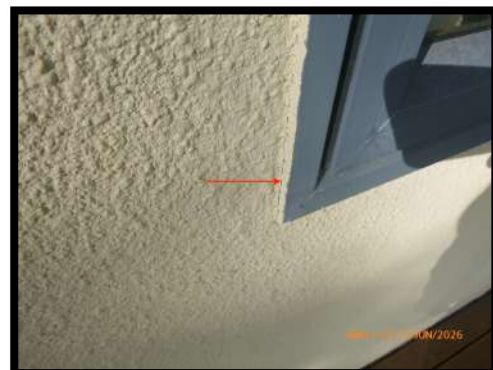
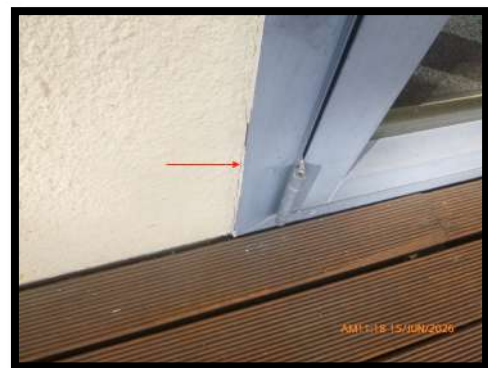
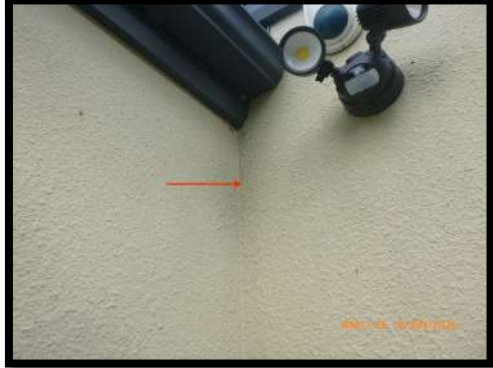
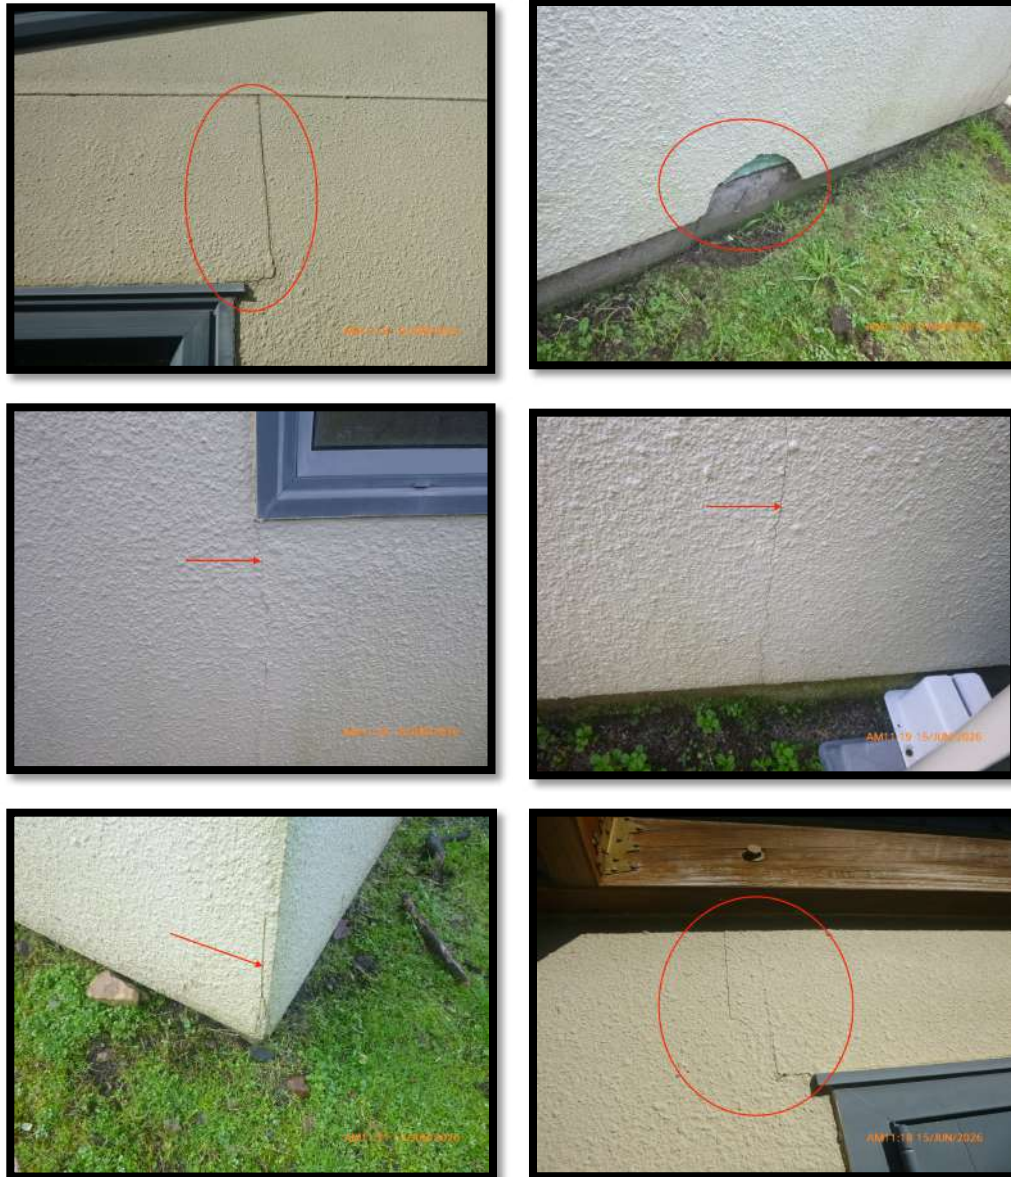
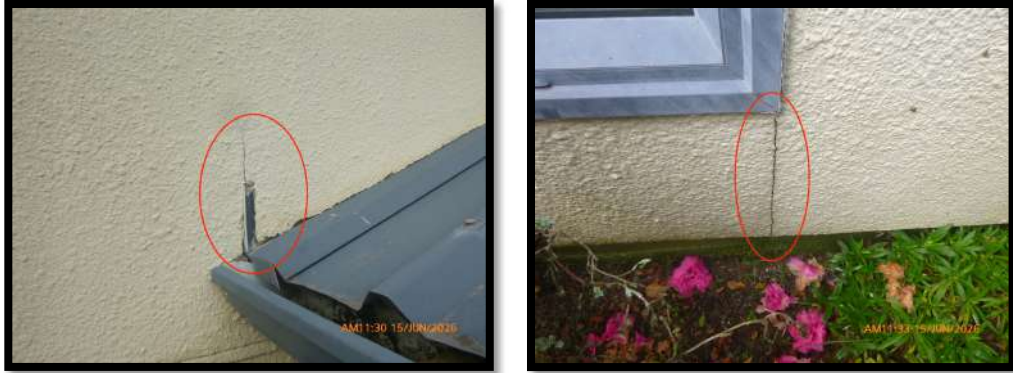
Several cracks and damages on the textured fibre cement cladding system. Cracking in this style of cladding system can hold moisture and can allow moisture to enter the building envelope. We are not certain on the condition of the timber frame behind these affected walls. Further investigation would be recommended. **Repairing any cracks or damage on the cladding system would be recommended to prevent moisture ingress into the dwelling. Regular inspection of the cladding system is required as part of the maintenance to ensure that any cracking or damage is urgently repaired.**

**Defect:** Several cracks and damages on the textured fibre cement cladding system. Cracking in this style of cladding system can hold moisture and can allow moisture to enter the building envelope. We are not certain on the condition of the timber frame behind these affected walls. Further investigation would be recommended.

Repairing any cracks or damage on the cladding system would be recommended to prevent moisture ingress into the dwelling. Regular inspection of the cladding system is required as part of the maintenance to ensure that any cracking or damage is urgently repaired.

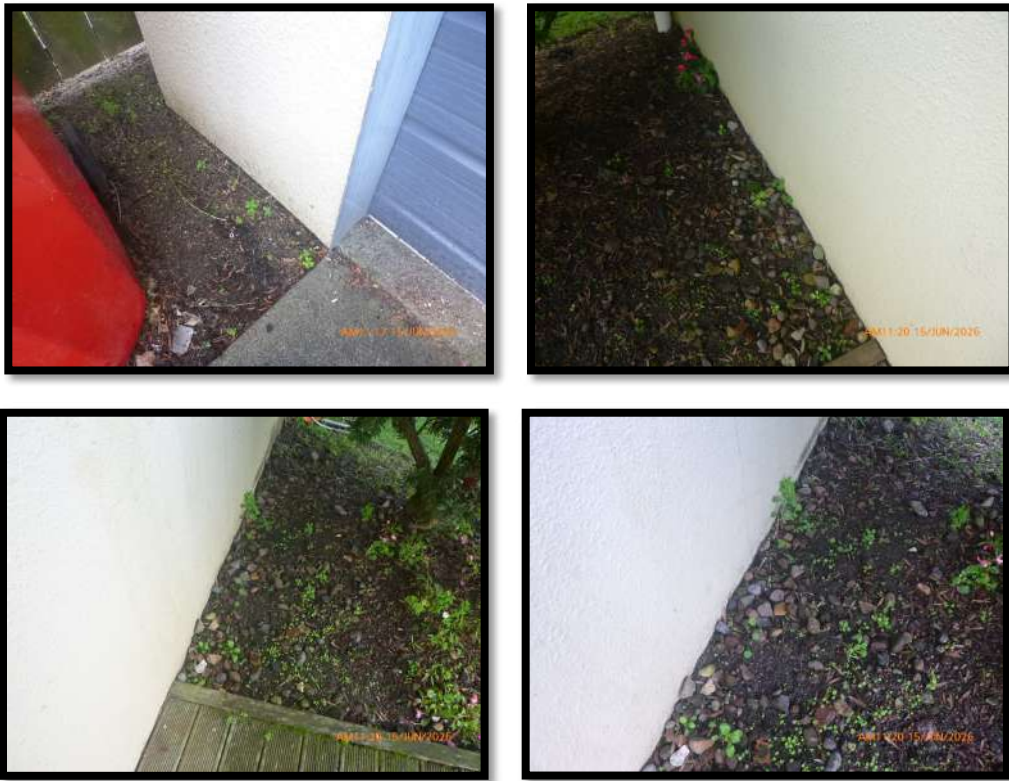
**Defect:** The unpaved ground is covering or touching lower part of the cladding. This is another weathertightness risk.

Textured fibre cement cladding must maintain a minimum bottom edge clearance of 100 mm from paved ground and 175 mm from unpaved (soil/earth) ground. These clearances are required by BRANZ and the Acceptable Solution NZBC E2/AS1 to prevent moisture ingress, capillary action, and wood rot. (From BRANZ)

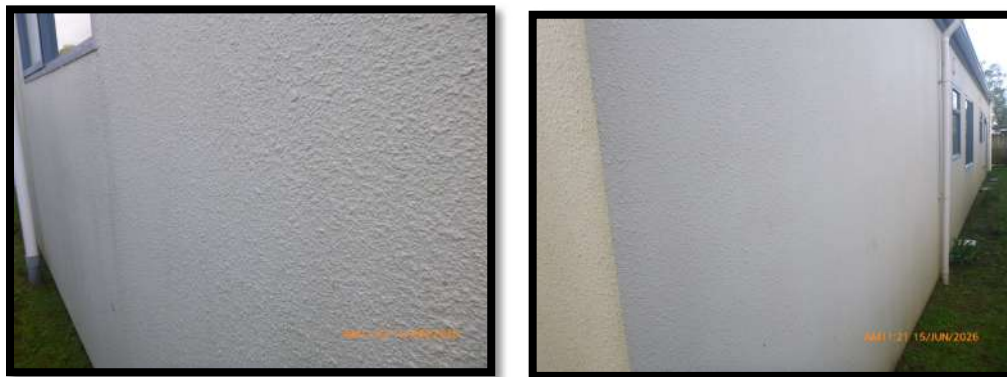
**Paint Finish of the Cladding:** The paint system to the exterior of the dwelling appears dull and faded.

We recommend repainting the exterior cladding.

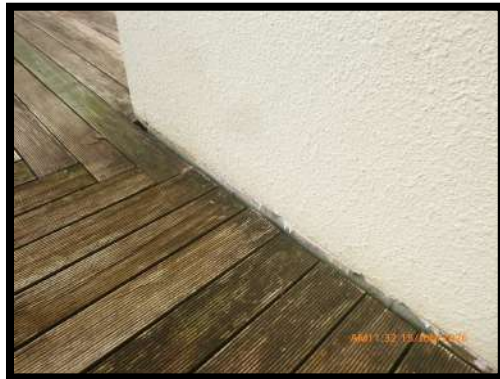
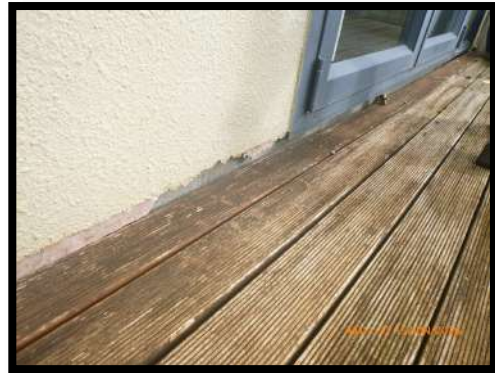
**Defect:** The timber deck has sagged. The floor frame and foundations of the deck could be damaged.

We recommend the repair of the sagging timber slats of the deck.

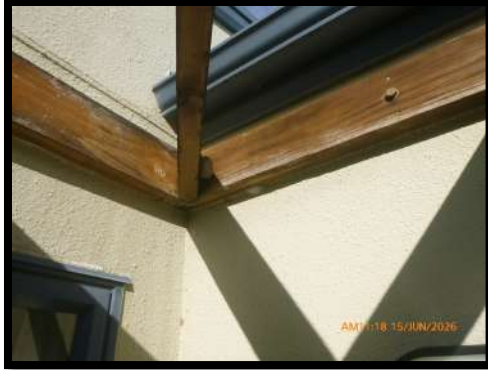
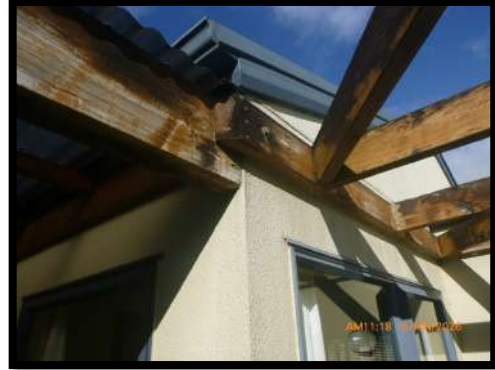
**Defect:** The girders of the pergola and roof frame of the deck had been directly attached to the cladding. This is a high weathertightness risk that could breach the NZ Building Code. We are not certain if this had been approved by the Council. Further investigation would be recommended.

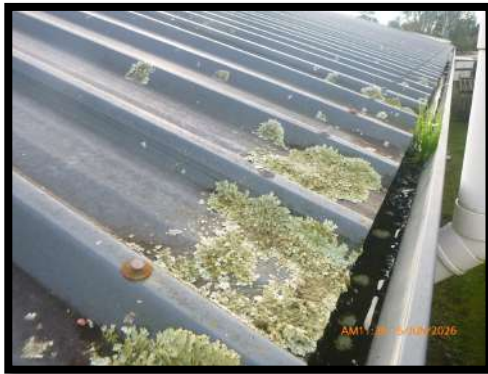
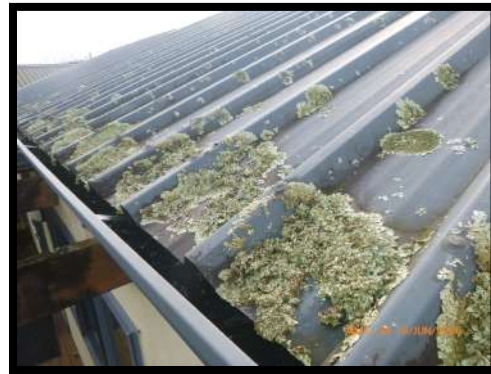
**Defect:** Moss and lichen growth on the roofing iron

We recommend treating the moss and lichen growth to remove from the roofing iron.

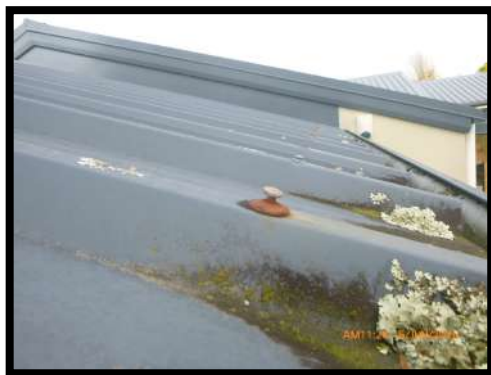
**Defect:** Popped roofing nails.

We recommend the reseating any popped roofing nails.

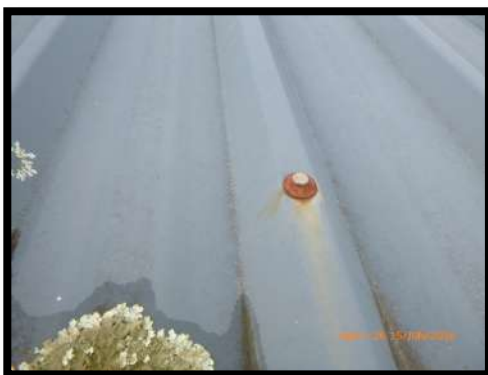
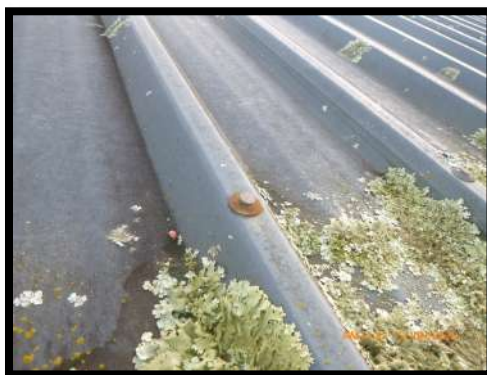
**Defect:** Rusted nail heads and washers. This could affect and damage the roofing iron in the future.

We recommend replacement of the roof nails with tex-screw that compatible with the roofing iron.

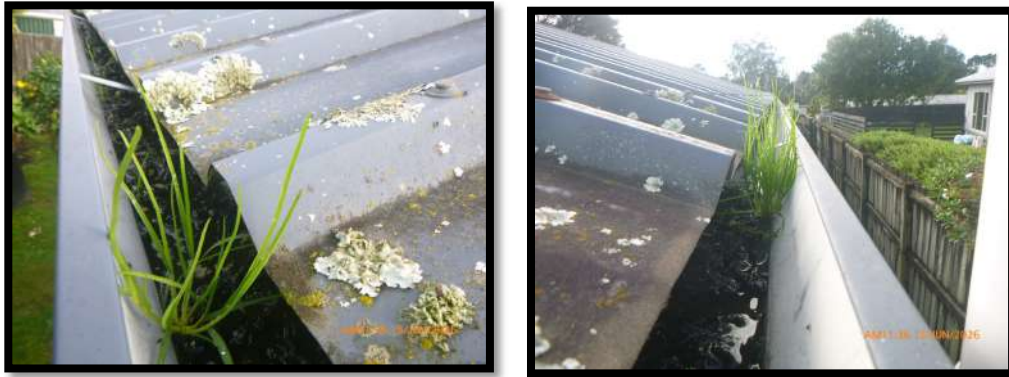
**Defects:** Debris in the gutters. Grass has grown in the gutters.

We recommend cleaning the gutters of debris.

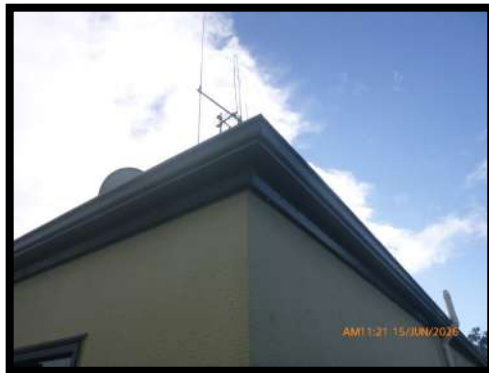
**Soffit:** No eaves and soffits. This a high weathertightness risk. Without soffits and eaves on direct-fixed textured fibre cement cladding removes the primary weather protection on the cladding. This could lead to moisture ingress, failed joinery flashing and hidden timber rot.

Under the Ministry of Business, Innovation and Employment (MBIE) Risk Matrix, zero eaves combined with direct-fixed cladding exceeds the acceptable weathertightness risk threshold for most habitable buildings.

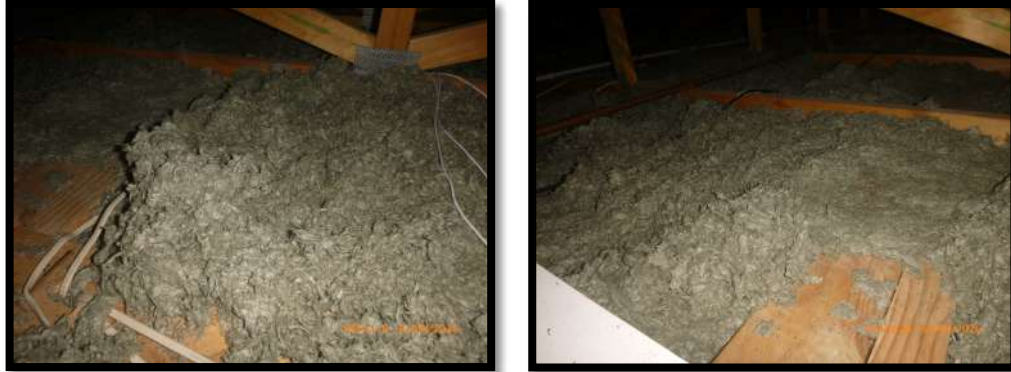
**Defect:** The blown insulation has shrunk.

We recommend topping up the old blown insulation with blanket or bulk insulation such as polyester, fiberglass and glasswool.

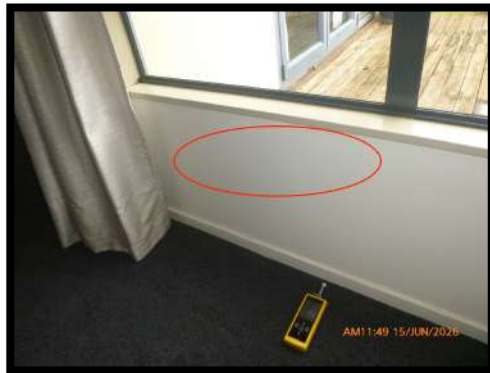
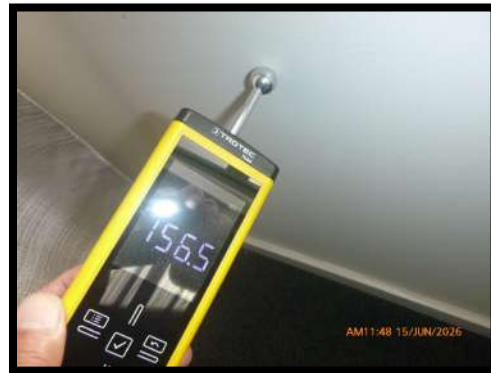
**Moisture Readings:** Very high moisture readings were recorded in the wall lining below the window sill indicating wet conditions. This could be due to leaks from the aluminium joinery. Further investigation would be recommended.

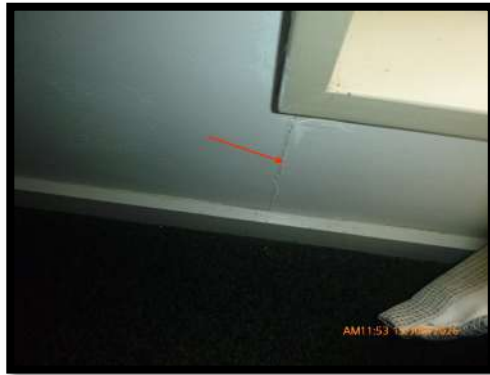
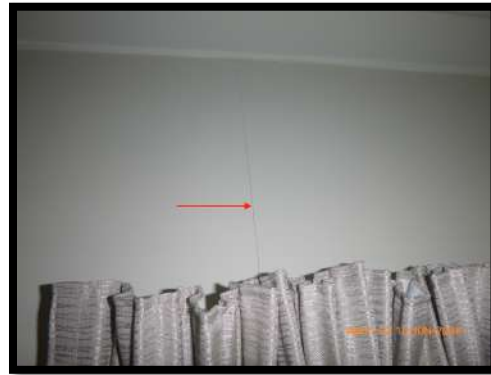
**Defect:** Cracks on the wall linings in the living room. This is normally due to settlement of the dwelling and thermal expansion/shrinkage.

We recommend the repair of any cracks or damage in the wall lining.

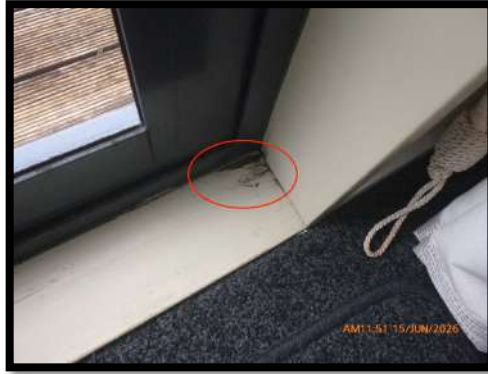
**Defect:** Decayed door sill in the living room.

We recommend the repair of any decaying door sill.

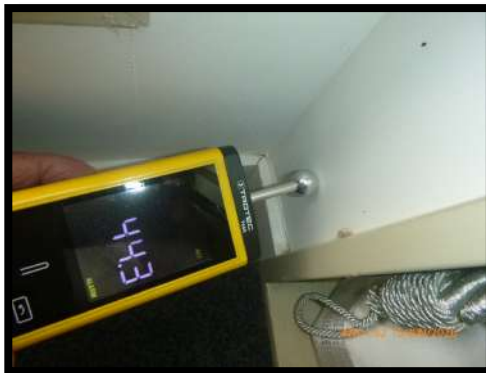
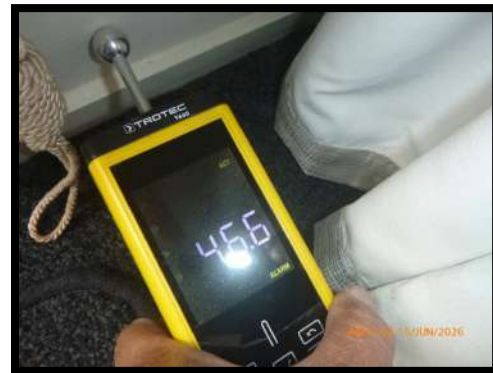
**Moisture Readings:** Elevated moisture readings were recorded in the wall linings in the living room indicating damp conditions.

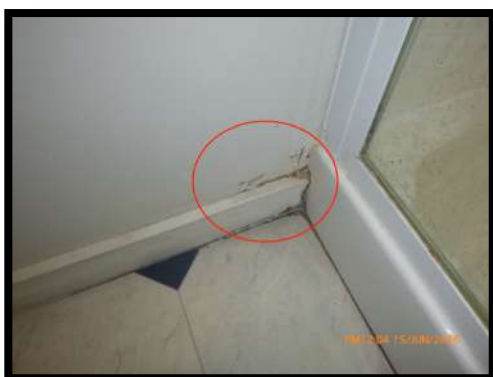
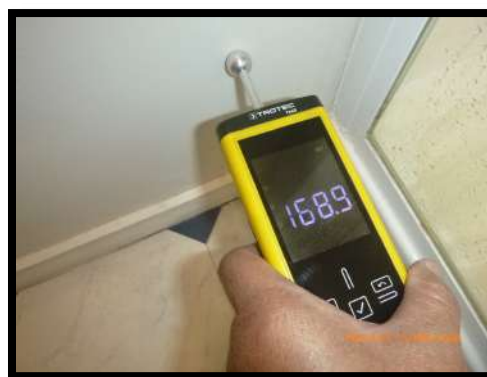
**Moisture Readings:** Very high moisture readings were recorded in the wall lining at the lower left corner of the shower cubicle indicating wet conditions. This could be due leaks from the internal corner of the shower cubicle. The wall lining and skirting appears soft and damaged. We are not certain on the condition of the timber frame behind the wall. Further investigation would be recommended.

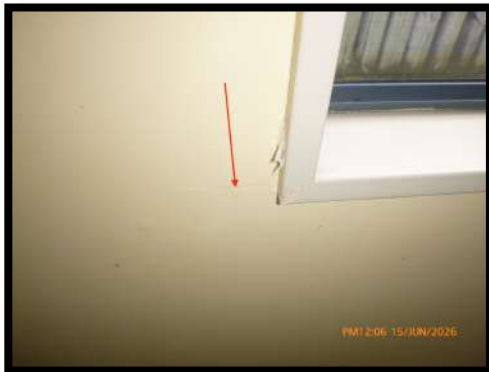
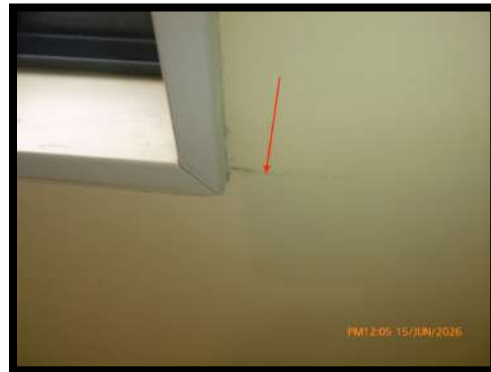
**Defect:** Horizontal crack on the wall lining in bedroom 2. A horizontal crack indicates movement of the ground.

We recommend the repair of any crack or damage in the wall lining.

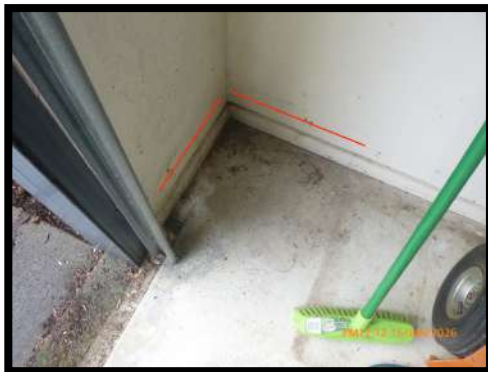
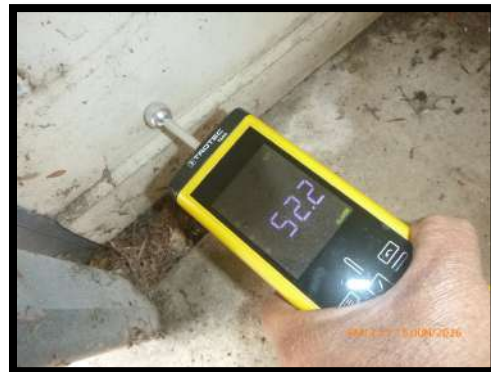
**Moisture Readings:** Elevated moisture readings were recorded in the lower part of the wall lining at the right side of the garage door indicating damp conditions. This could be due to moisture wicking from the driveway. Further investigation would be recommended.

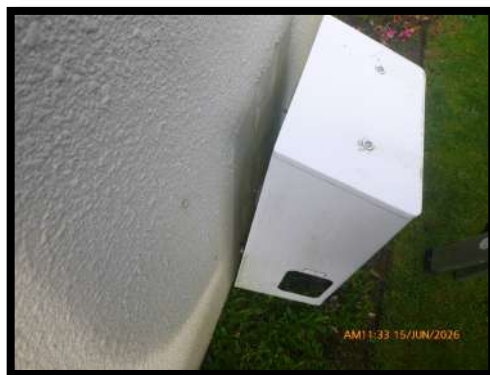
**Defect:** The meter board housing had been detached from the cladding.

We recommend reattaching the meter board housing.
