Our Reference: 12855

SOIL TESTS AND SITE ASSESSMENT NZS 3604 Soil Capacity Testing and Site Suitability

Lot 3 Court, Hamilton.

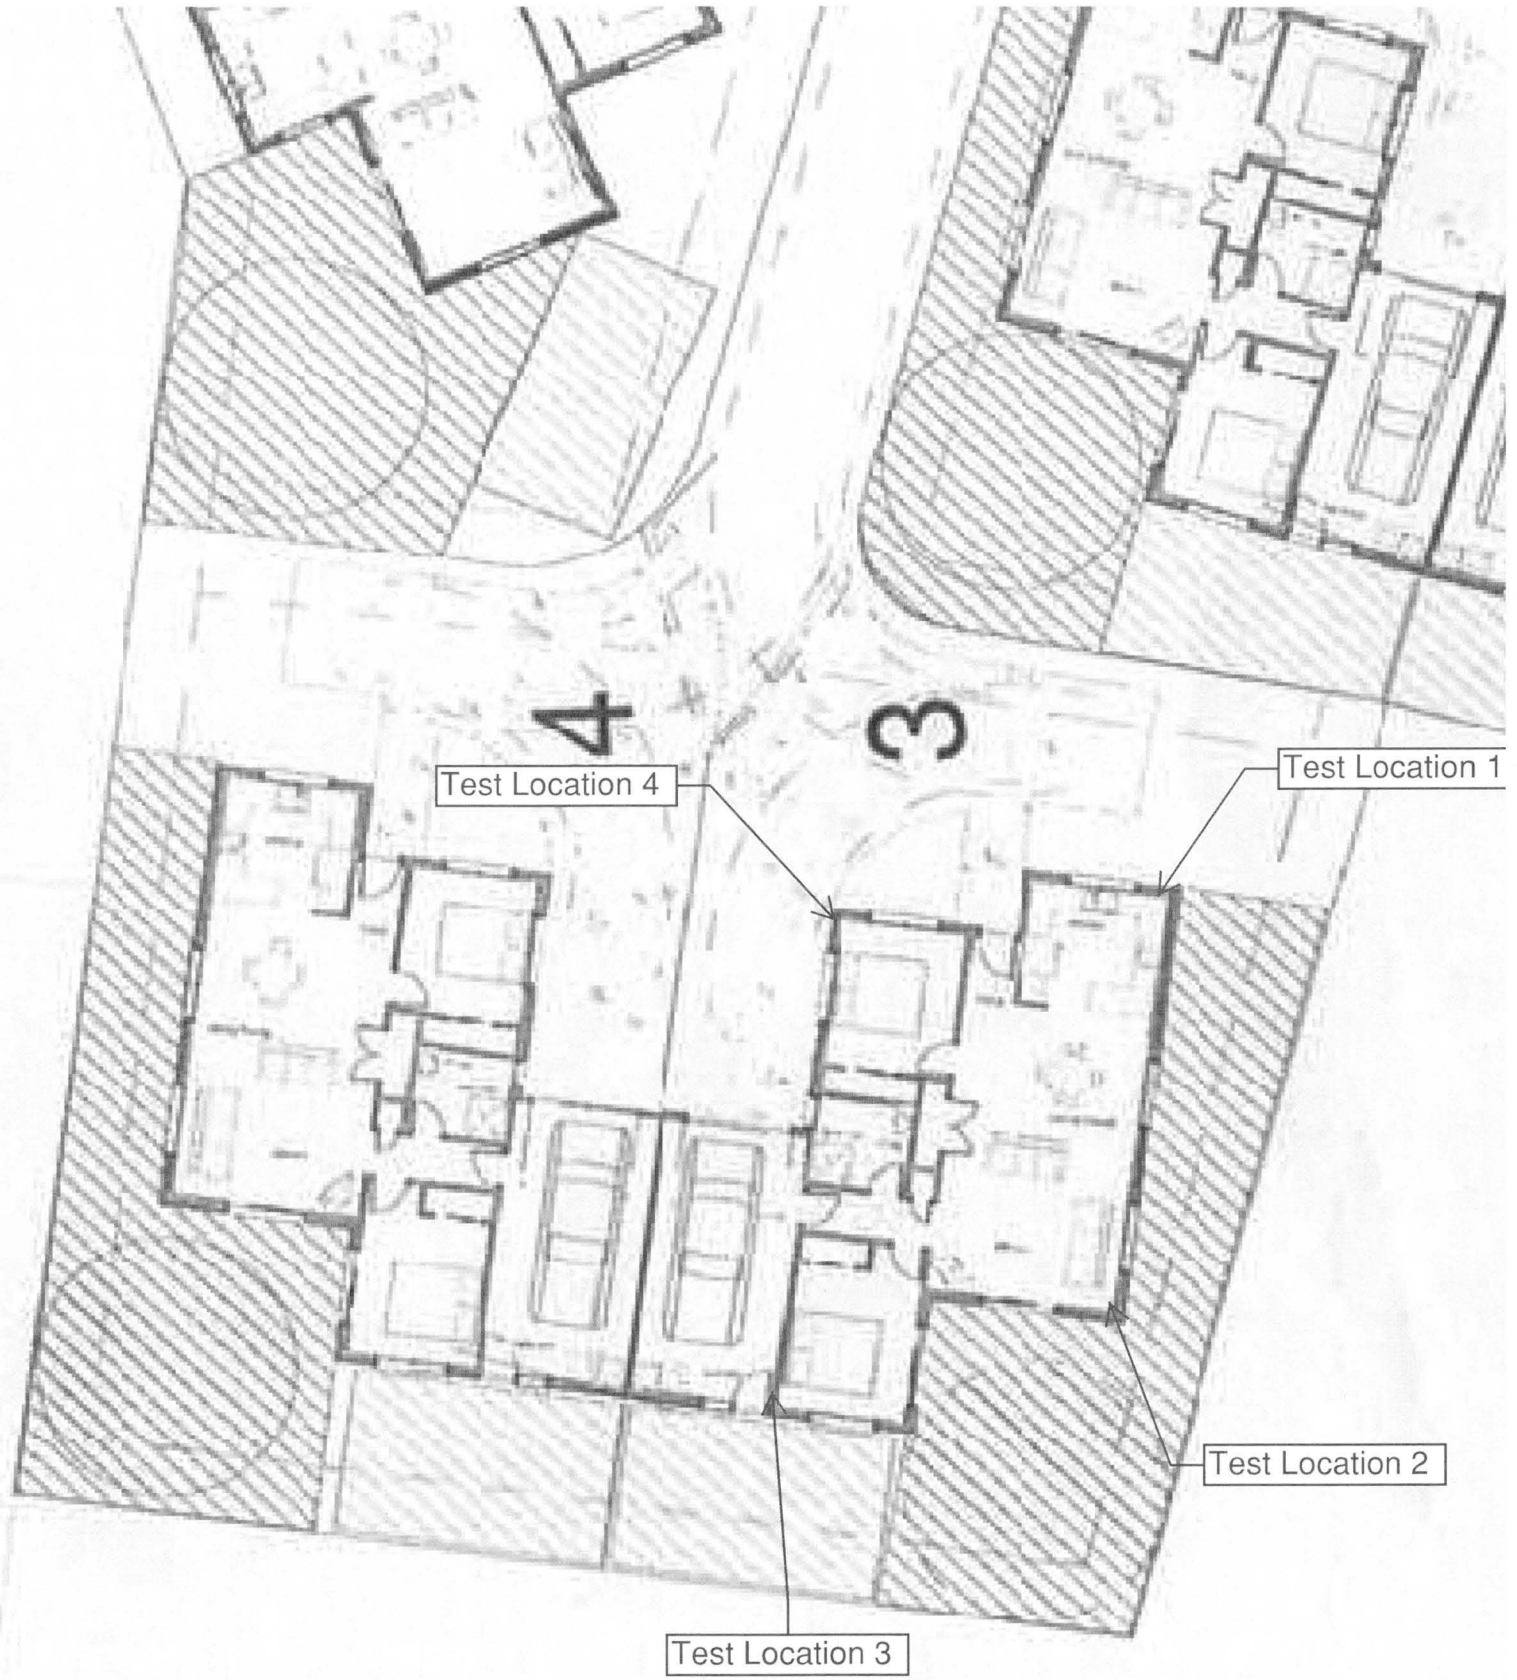
Soil Investigation Results

The soil test results and locations are shown in the attached appendix A

Four 50mm Auger holes were excavated at the locations shown in appendix A.

Scala Penetrometer tests were carried out at the locations as shown in appendix A, to a maximum depth of 3000mm.

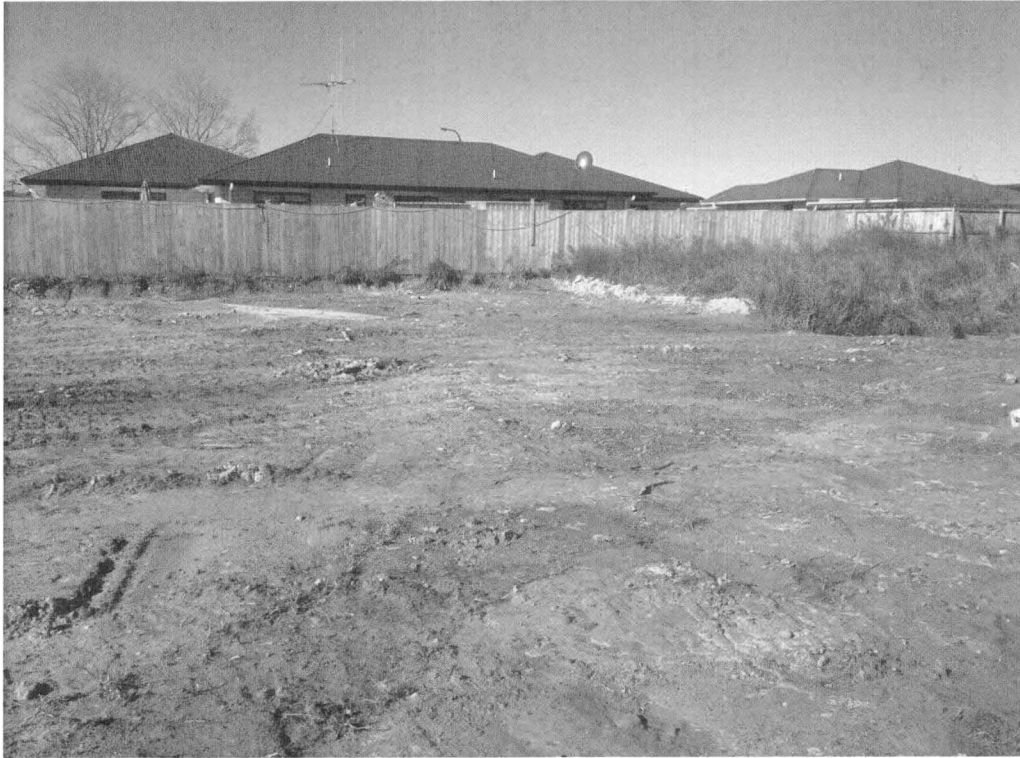
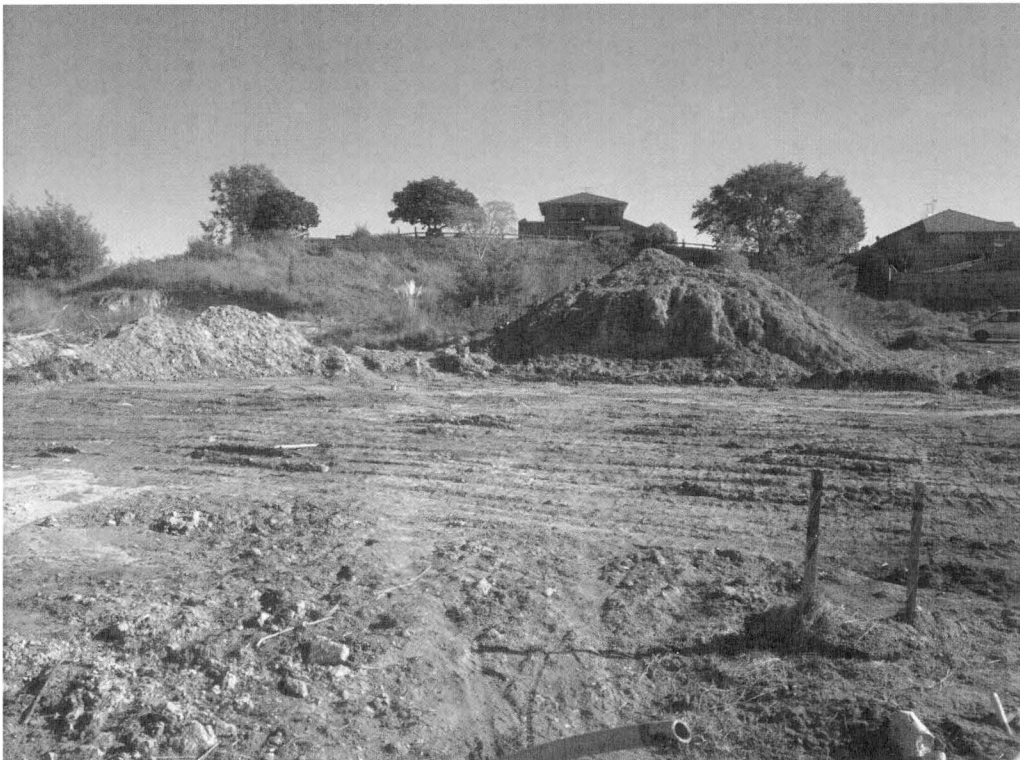
Site Photos

The site is generally flat.
