# ***Building Report with Weathertightness Risk Assessment***

***14A Riverlea Road  
Hamilton***

***15 June 2026***

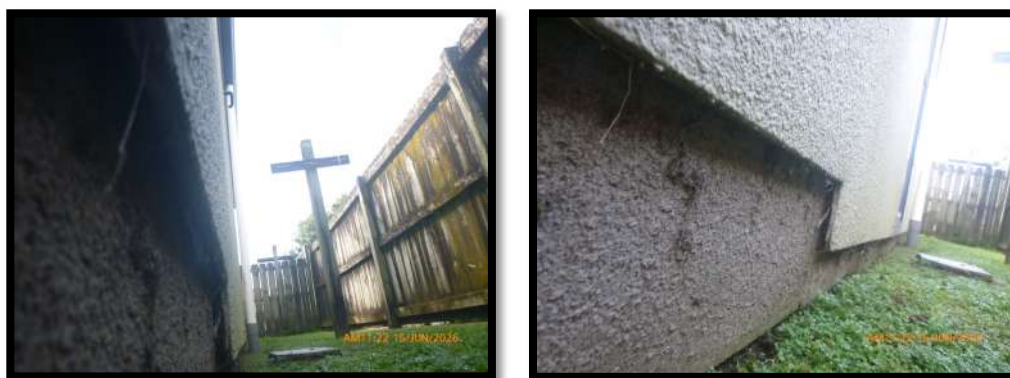
The cladding appears to have been fixed directly to the timber frame.

This has complied with the regulations in force during the time of its construction. However, this is a high weathertightness risk assessment as moisture could penetrate through the cracks in the cladding and into the timber frame.

**Defect:** Several cracks and damages on the textured fibre cement cladding system. Cracking in this style of cladding system can hold moisture and can allow moisture to enter the building envelope. We are not certain on the condition of the timber frame behind these affected walls. Further investigation would be recommended.

Repairing any cracks or damage on the cladding system would be recommended to prevent moisture ingress into the dwelling. Regular inspection of the cladding system is required as part of the maintenance to ensure that any cracking or damage is urgently repaired.

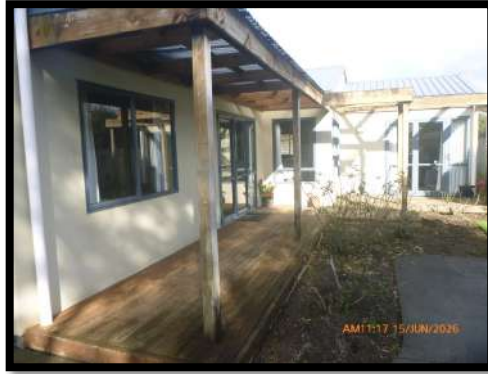
**Defect:** The timber deck has sagged. The floor frame and foundations of the deck could be damaged.

The timber deck has sagged. The floor frame and foundations of the deck could be damaged. **We recommend the repair of the sagging timber slats of the deck.**

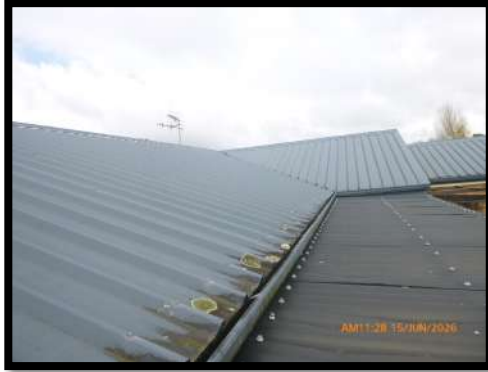
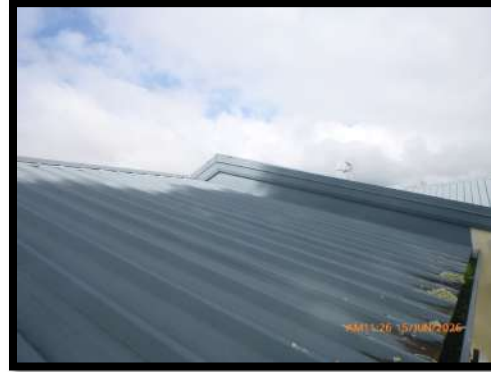
**Defect:** Moss and lichen growth on the roofing iron

Moss and lichen growth on the roofing iron. **We recommend treating the moss and lichen growth to remove from the roofing iron.**

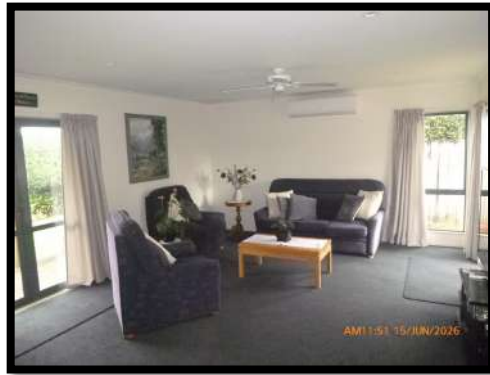
**Defect:** Cracks on the wall linings in the living room. This is normally due to settlement of the dwelling and thermal expansion/shrinkage.

Cracks on the wall linings in the living room. This is normally due to settlement of the dwelling and thermal expansion/shrinkage. **We recommend the repair of any cracks or damage in the wall lining.**

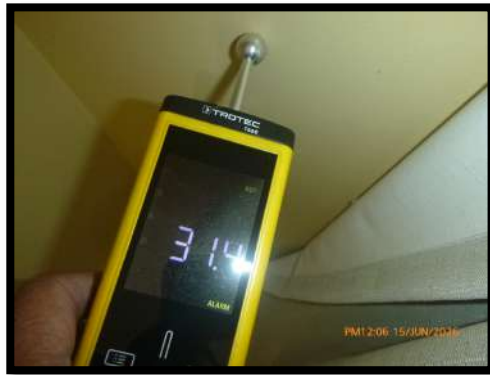
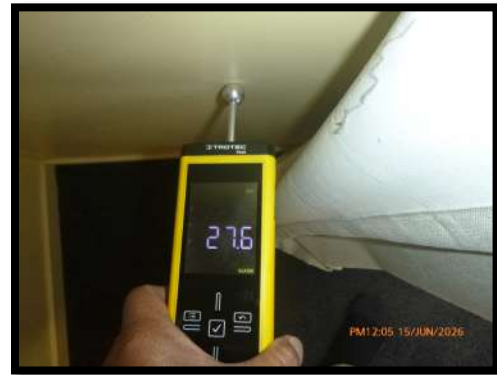
**Moisture Readings:** Low moisture readings were recorded indicating dry conditions.

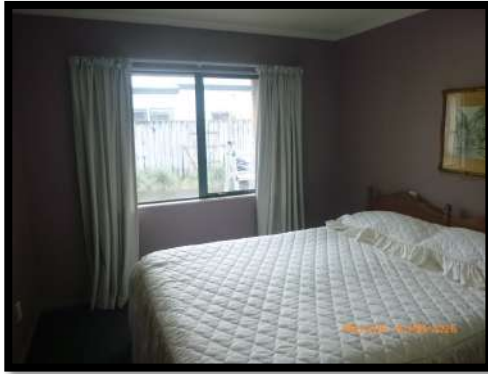
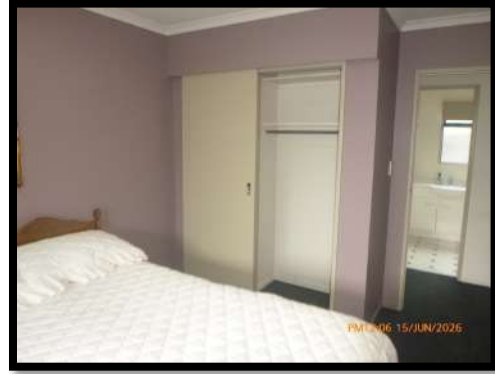
### Bedroom 3

**Moisture Readings:** Low moisture readings were recorded indicating dry conditions.

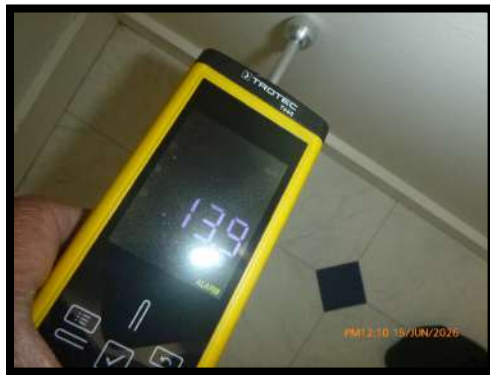
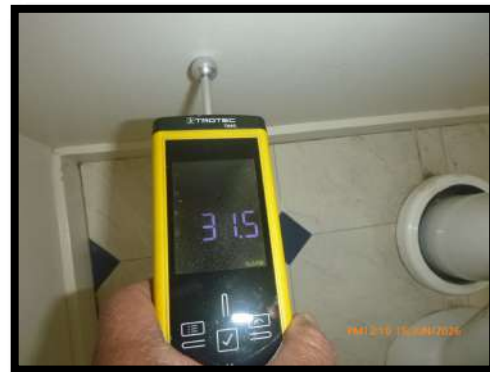
## Main Toilet

**Moisture Readings:** Low moisture readings were recorded indicating dry conditions.

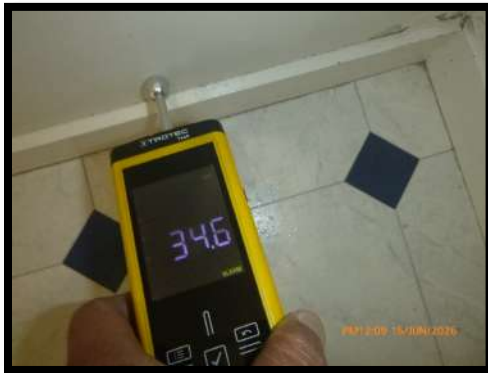
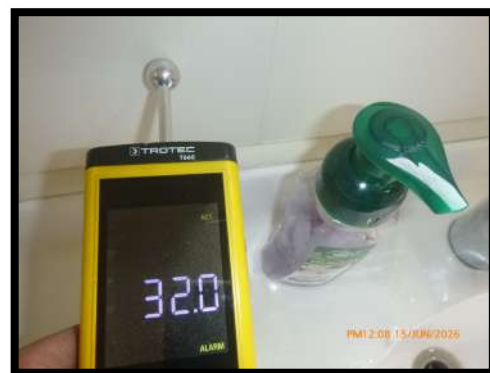
## Main Bathroom

**Moisture Readings:** Elevated moisture readings were recorded in the door frame and skirting indicating damp conditions. This could be due to moisture from leaks in the shower cubicle. Further investigation would be recommended.

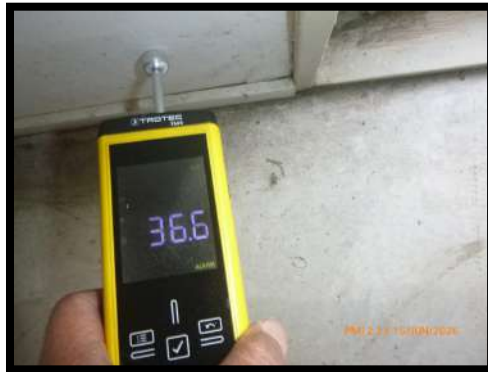
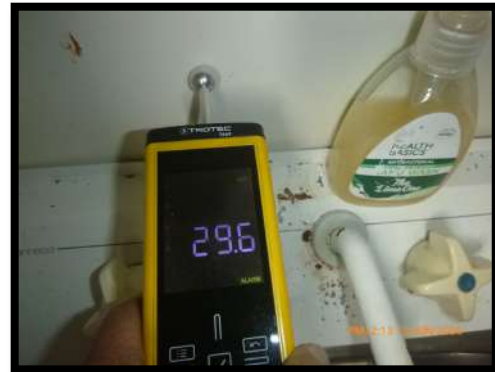
## Laundry

**Moisture Readings:** Low moisture readings were recorded indicating dry conditions.

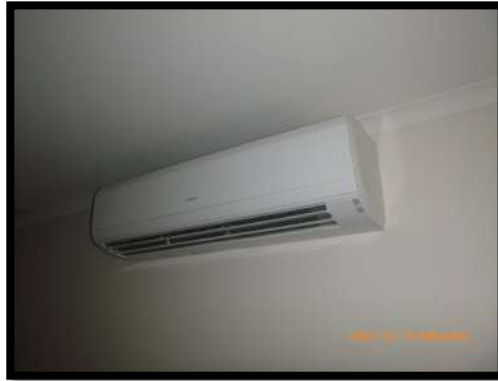
**Heating:** Heat pump. Functional. This should be re-tested prior to settlement of the property.

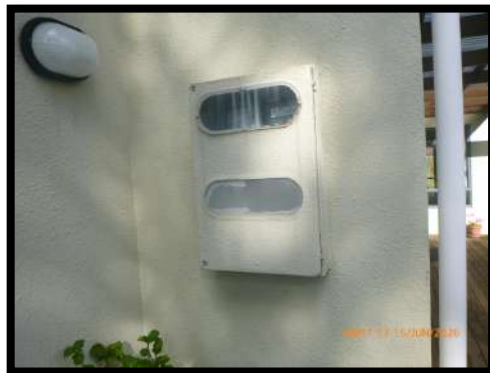
**Gas Services:** Meter board at the right side of the dwelling.

**Defect:** The meter board housing had been detached from the cladding.

We recommend reattaching the meter board housing.

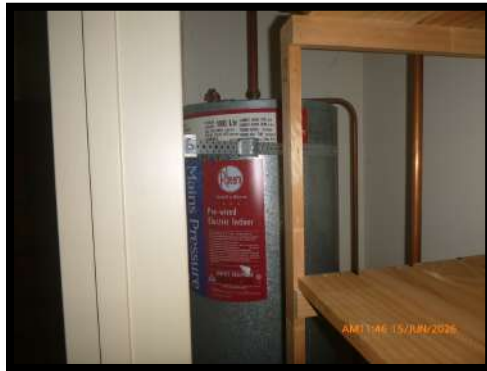
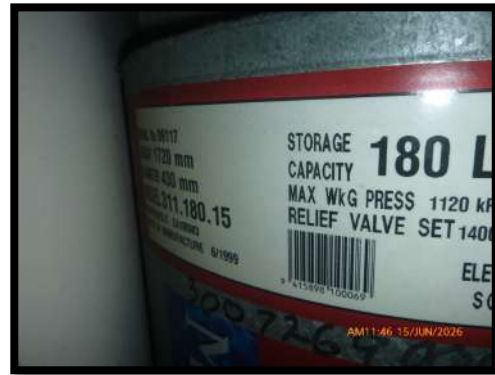
**Hot Water Services:** 180L capacity mains pressure electric hot water cylinder.  
Date of manufacture: 6/1999.
